THE WHAT:

This is an example how to convert an old EJ20G to work with '02+ WRX ignition coils.

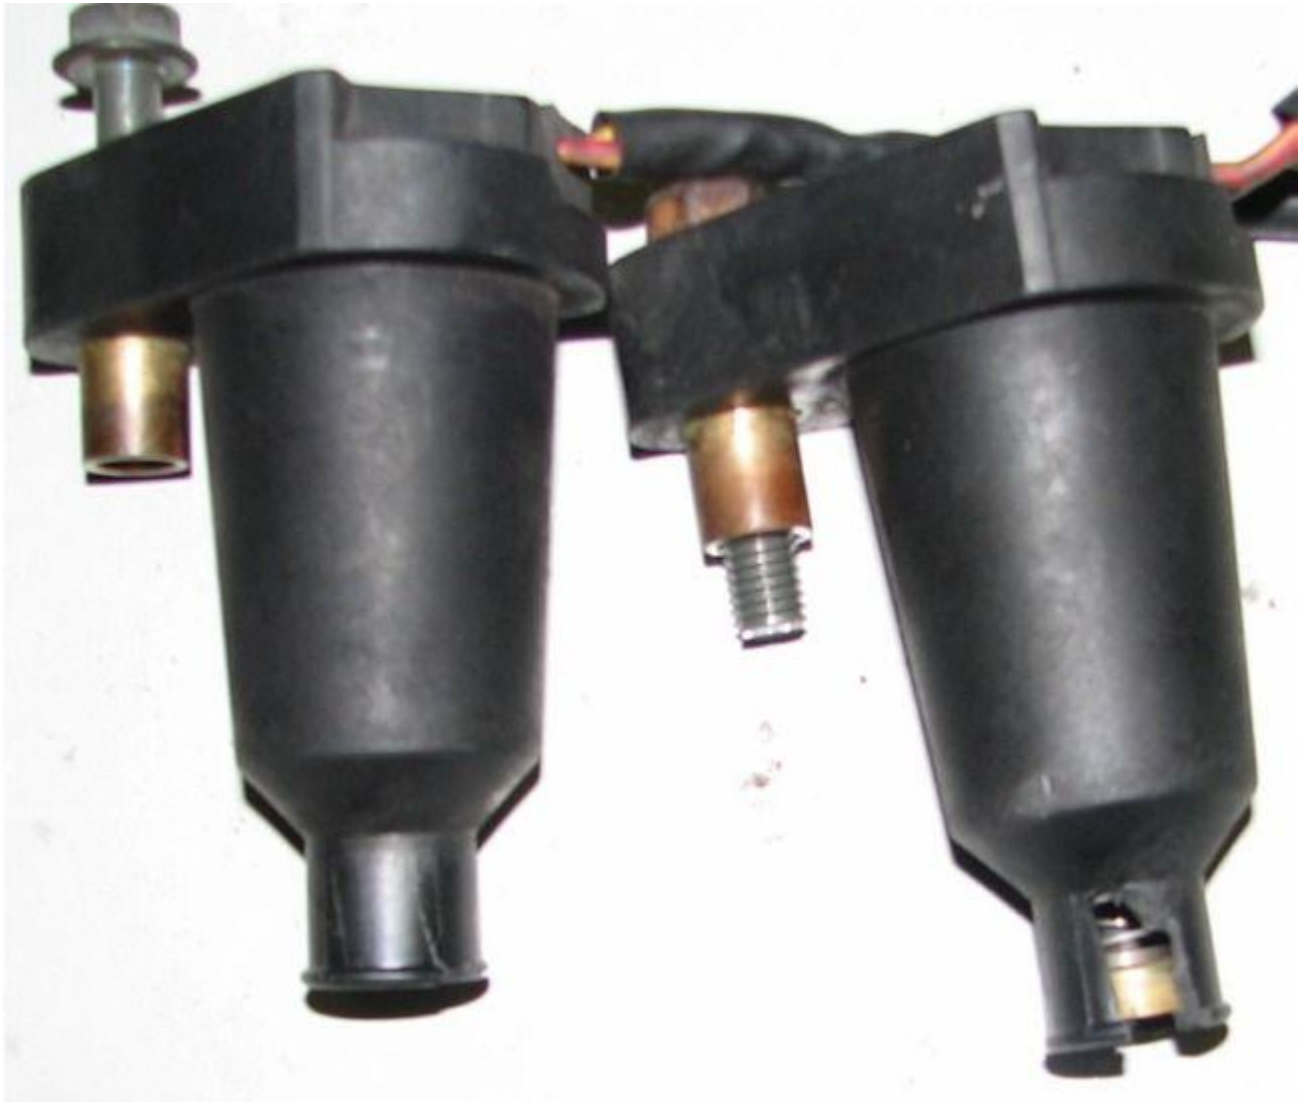
The EJ20G coils are notorious for failing with age and causing misfires. I had misfires at anything over 0.8 bar, that was traced to two coils that developed cracks in the housing. Below is what I found (I removed the cracked piece on the one on the right to see what was on the inside).

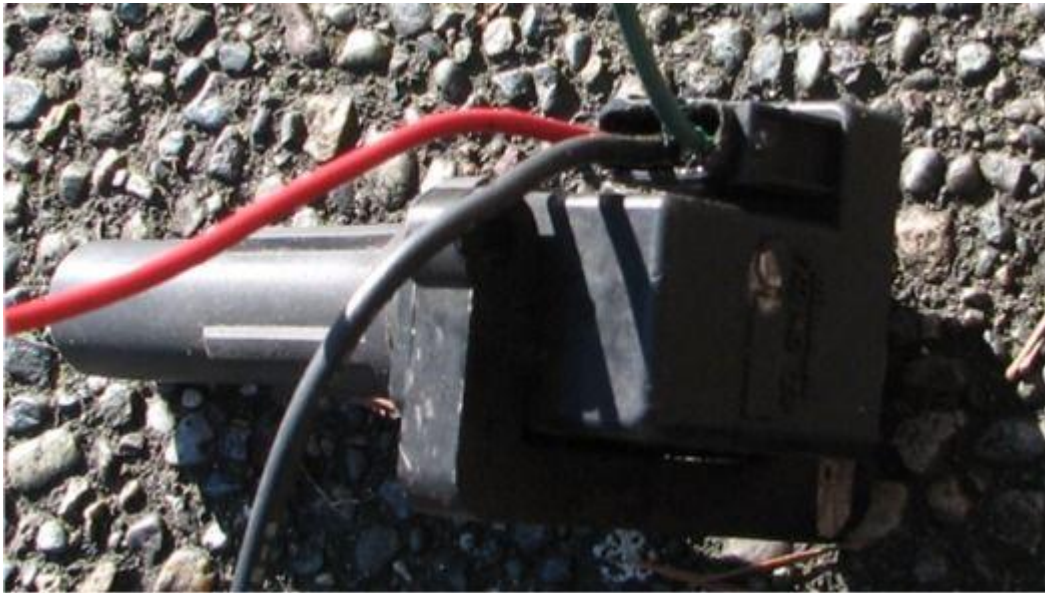
Using the above picture as a reference, the pinning is as follows from left to right:

Pin1 : Pin2: Pin3
+12v : GND : Trigger
Red : Blk : Green <--- wire colors I used in my picture
RY : BY : GY <--- '02 WRX harness colors

2. The easiest solution is if you have the matching connectors for the new coils from the '02+ harness. I didn't, so I soldered new wires directly to the coils, then attached the old pigtails to the new wires.

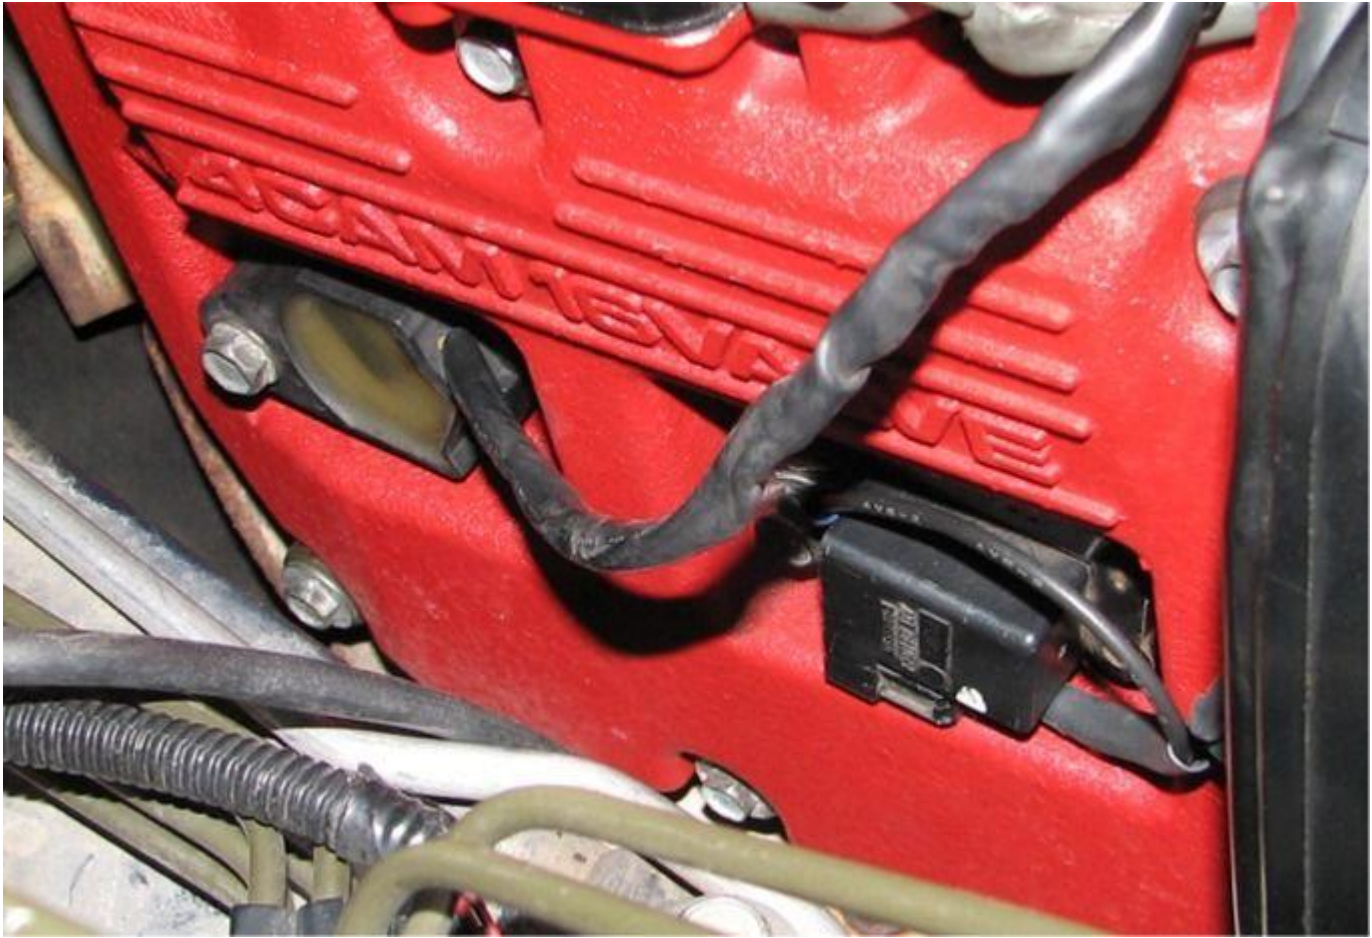
3. The coil fits in the early WRX heads perfectly, however there are some fitment issues with the Liberty version of the motors. The engine harness has two coil connectors for each side. The grey connector is for the front coil, the black is for the rear.
